Casting Defects Analysis in Forging and Their Remedial Measures with Industrial practical Studies

Rohtash Kumar¹

¹(M.tech, Department of Mechanical Engineering, M D U Rohtak, Haryana, India)

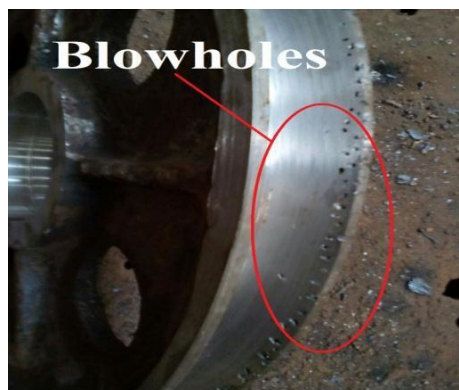
Fig.2. Blowhole

Sheave of Grade 270-540 IS1030 undertaken for study showed blowholes on groove edges.

- High moisture on chills.
- Low permeability of sand.
- Improper sand mixing.
- Inadequate vents.
- Use of undried coatings.
- High turbulence during filling.
- High bentonite content.
- Excessive Gas Entrapment.
- Liquid metal not properly degassed.
- High binder content.

- Avoid over ramming of sand.
- Use dry chills only.
- Optimum pouring temperature at 1585 degree centigrade for mild steel.
- Avoid using fine sand grains.
- Provision of adequate venting.
- Use dried and properly dressed cores.
- Reduce binder and additives.
- Control of Aluminum level.
- Increase runner height for increased static pressure.
- Adjust carbon equivalent value.
- Use water based zircon coatings.

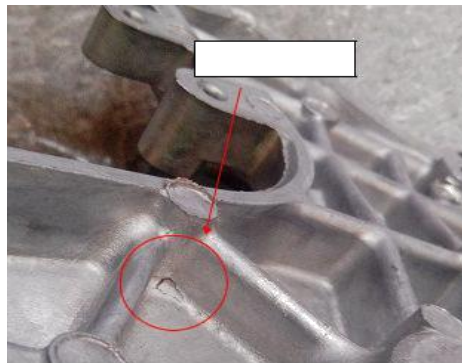
Fig.4. Shrinkage

Left crank case of aluminum ADC12 undertaken for study showed internal shrinkage defect towards the centerline.

- Less metal
- Improper die cooling
- Abrupt change in area of cross section in casting
- Forcefully removed casting
- Too many sharp internal corners causing hot-spots isolation.

- Dry mould using CO₂ gas for at least 60 seconds for high rigidity.
- Use of chills at correct position to for directional solidification.
- Feeding of sharp corners to avoid hot spots.
- Riser to be properly located.
- Use of inoculants.

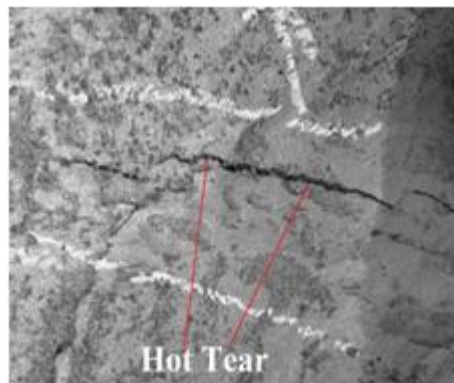
Fig.6. Hot Tears

Bottom Chock of Grade EN-9 alloy undertaken for study showed hot tear near thick sections.

- Use of coarse size sand grains.
- Mould disturbance before complete solidification.
- Imperfect riser location.
- Abrupt changes to be avoided which increase internal stress
- High binder and ramming density
- Hydrogen content too high
- Low amount of eutectic cells at grain boundary
- Excess amount of sulphur/phosphorus present

- Sufficient cooling of mould to be done.
- Avoid sharp turns/corners.
- Provision of draft during removal.
- Deoxidize to kill sulphur/phosphorus present.
- Use inoculants mixture of Mn/Si/Mg to reduce sulphur/phosphorus content.
- Use of fine sand grains.
- Add coal dust to increase eutectic cells during solidification.

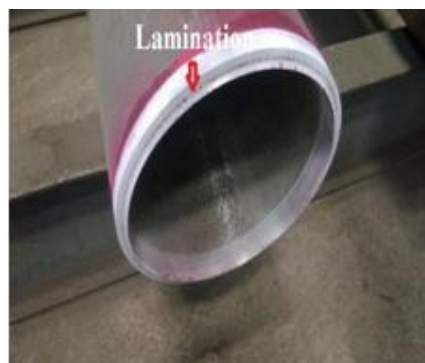
Fig.8. Lamination

Centrifugally Casted Pipe of Grade SS HK40 undertaken for study showed lamination defect protruding from pipe periphery.

- Use of low quality charge metal and scrap.
- Low rpm or extremely high rpm during pipe solidification.
- Friction between pipe die and material is low.

- Pipe to be rotated at optimum speed of 500rpm.
- Use of best quality materials for charging.
- Locking of pipe die by correct flange size.
- Asbestos sheet for packing should be of good quality and properly aligned in pipe die.

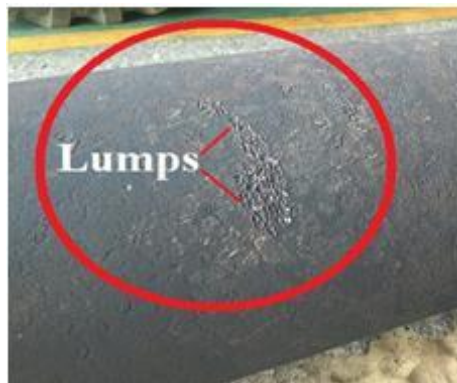
Fig.10. Lumps

Centrifugally Casted Pipe of Grade SS HK40 undertaken for study showed lumps defect on pipe surface

- Present of air voids in pipe die& metal interface.
- Low adhesion between metal and pipe during rotation.

- Increase rotation speedup to 475 to 500 rpm.
- Proper preheat of pipe die.
- Pouring ladle and die to be free from any foreign particles.
- Increase number of mould coatings inside pipe die.

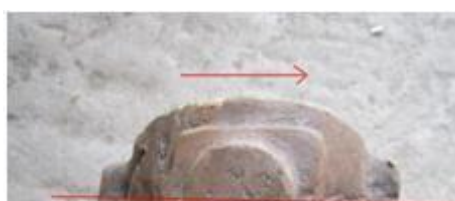
Fig.16. Mismatch

Valve of Grade ASTM A216 WCB undertaken for study showed mismatch.

- Clamping cope and drag using worn out dowels.
- Faulty pattern designs of top and bottom parts.
- Inadequate amount of weight kept on cope part.

- Use of proper gating system.
- Heavy weight to be kept on top of casting. ensuring no dislocation of cope part.
- Ensure top and bottom parts are aligned properly.
- Replace worn out dowel pins with new ones.
- Use locators to match top & bottom parts.
- Use C-Clamps to clamp the mould box.

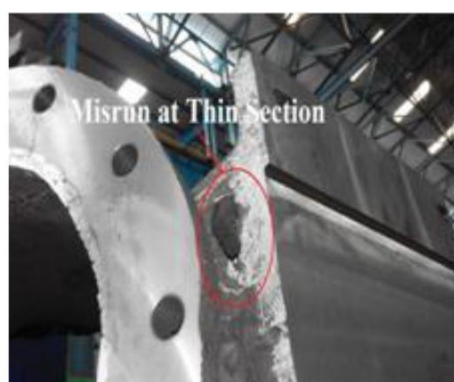
Fig.18. Misrun

Wind Box of Grade SG500/7IS1865 undertaken for study showed misrun defect at thin section.

- Lower pouring temperature.
- Intermittent Pouring.
- Pouring Delayed.
- Back Pressure during Pouring.
- Inadequate venting.

- Sufficient pouring temperature to ensure fluidity.
- Design proper gating system.
- Cleaning of mould box before pouring.

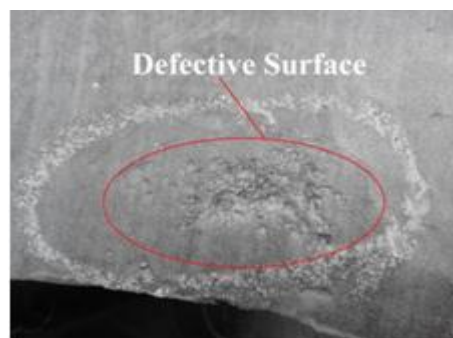
Fig.20. Defective Surface

Valve of Grade ASTM A216WCB undertaken for study showed defective surface at flange face.

- Formation of oxide films.
- Foreign impurities flowing on casting surface.
- Low temperature of mould.
- High slag content.

- Preheat the mould before pouring
- Check for slag formation during charge

- Pouring temperature to be lowered
